# Rexroth HydraulicDrive

HDx-20VRS  
Firmware for drive controllers

**Firmware Release Notes**  
**RE 30330-RN**

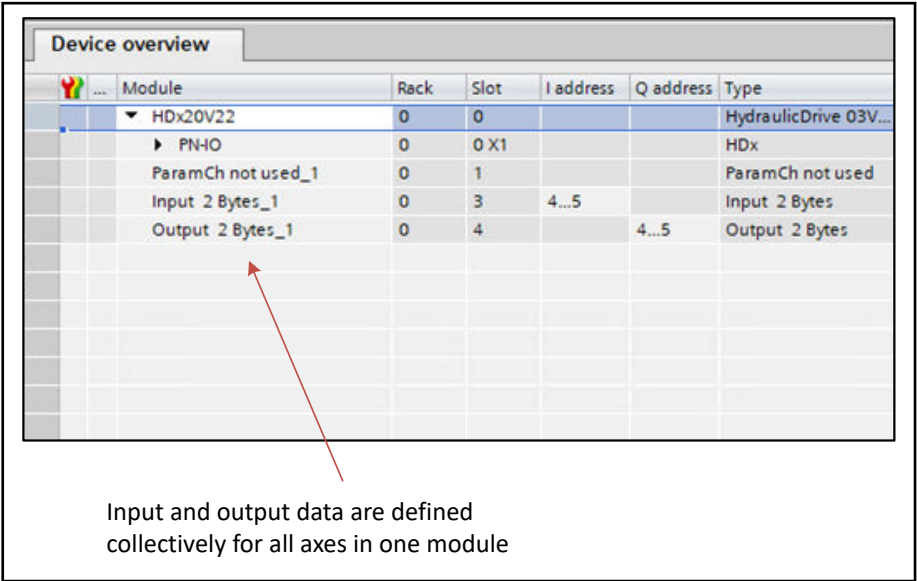
Fig. 22-1: Definition of input and output data in one module

**Description** Within the framework of release HDx20V22 the PROFINET interface of the HydraulicDrive devices was extended. Therefore, the PROFINET interface of the VT-HMC with 2 axes (R901441904, VT-HMC-2-1X/M-0-00/00) had to be adapted. So far, the input and output data were defined for each axis of the VT-HMC in separate modules. **As of release HDM20V22 the input and output data have to be defined for all axes together in one module.**

For the configuration of the VT-HMC with 2 axes the current description file **GSDML-V2.4-Bosch\_Rexroth\_AG-011F-Hydraulic-Drive\_03V00-20210608.xml** has to be used.
